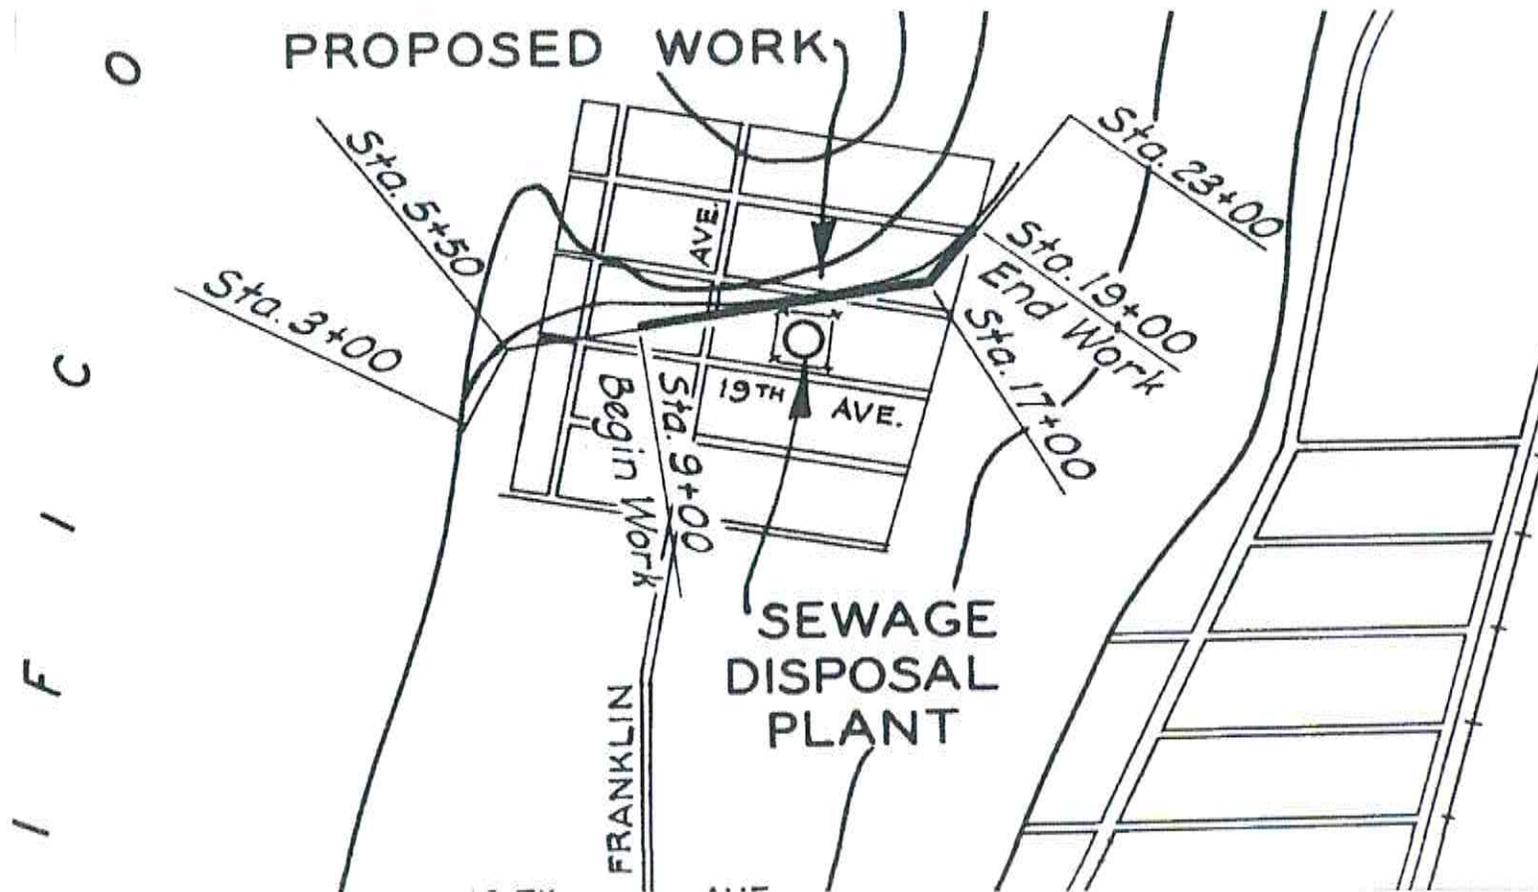
# 1948-49

Bad storms that winter caused massive erosion at the north end of town and threatened the City's sewer treatment plant. The Corps of Engineers mobilized and designed and constructed an emergency repair. A rock revetment was built that spanned from near the end of Columbia Street, across the north end, almost to the banks of the Necanicum River. These plans were discovered in the Portland office archives several years ago.

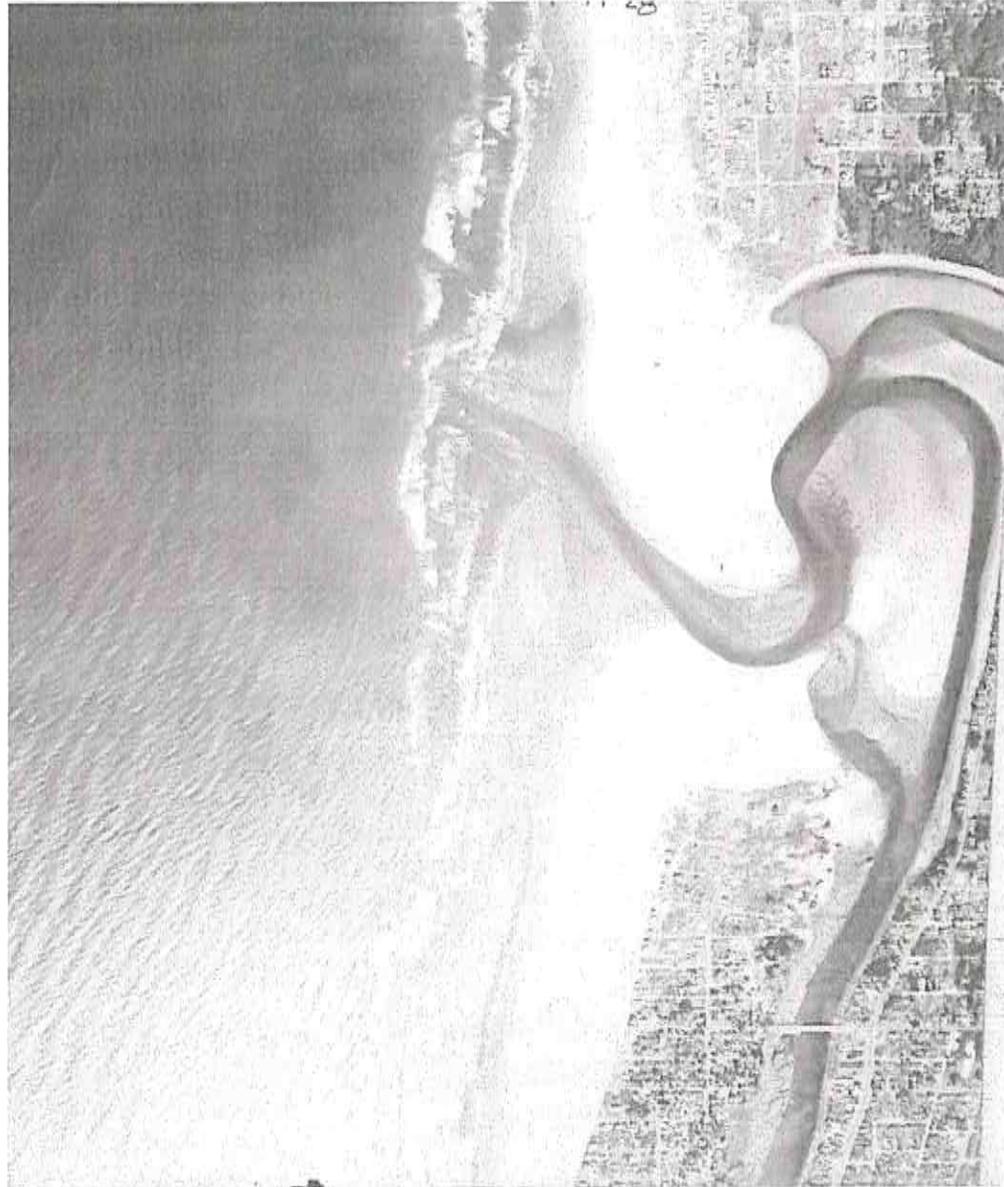
# 1953

The Revetment is in place and working. Sand has built up substantially north of the Corp's repair work.

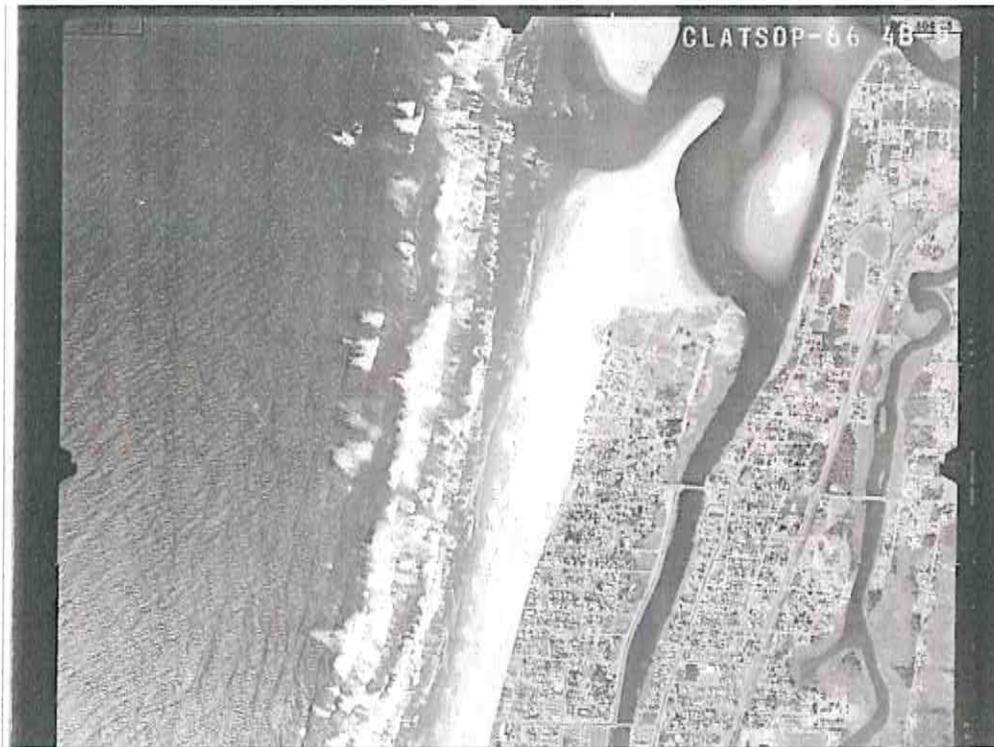
# 1966

By 1966 a long finger of land has developed. It is over 1500 feet from The sewer plant out to the point. There was enough land north of the Plant that it started to attract developers.

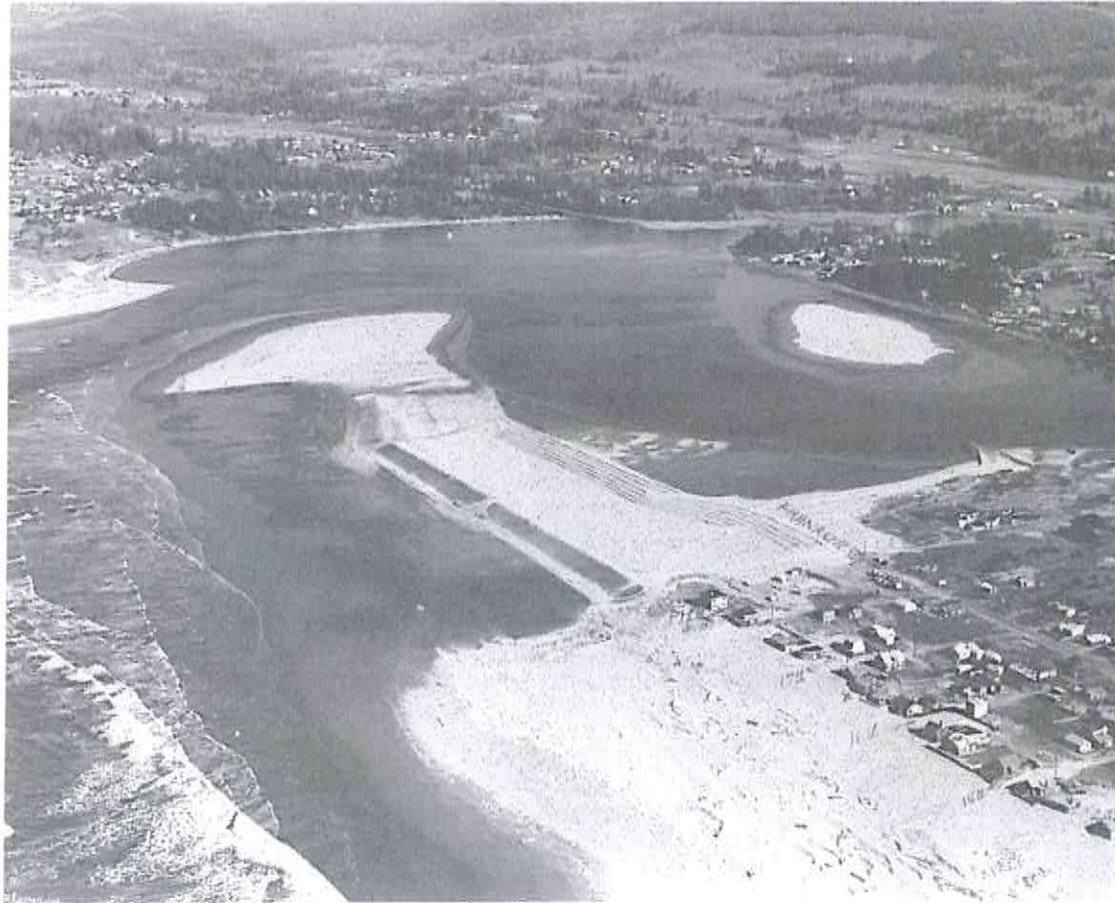
# 1967

Shortly after the 1966 photo a developer got permission to mine sand off of the Seaside beach. He moved Countless thousands of cubic yards of sand up to the north of the plant and then armored the west face up and around the end of the spit.

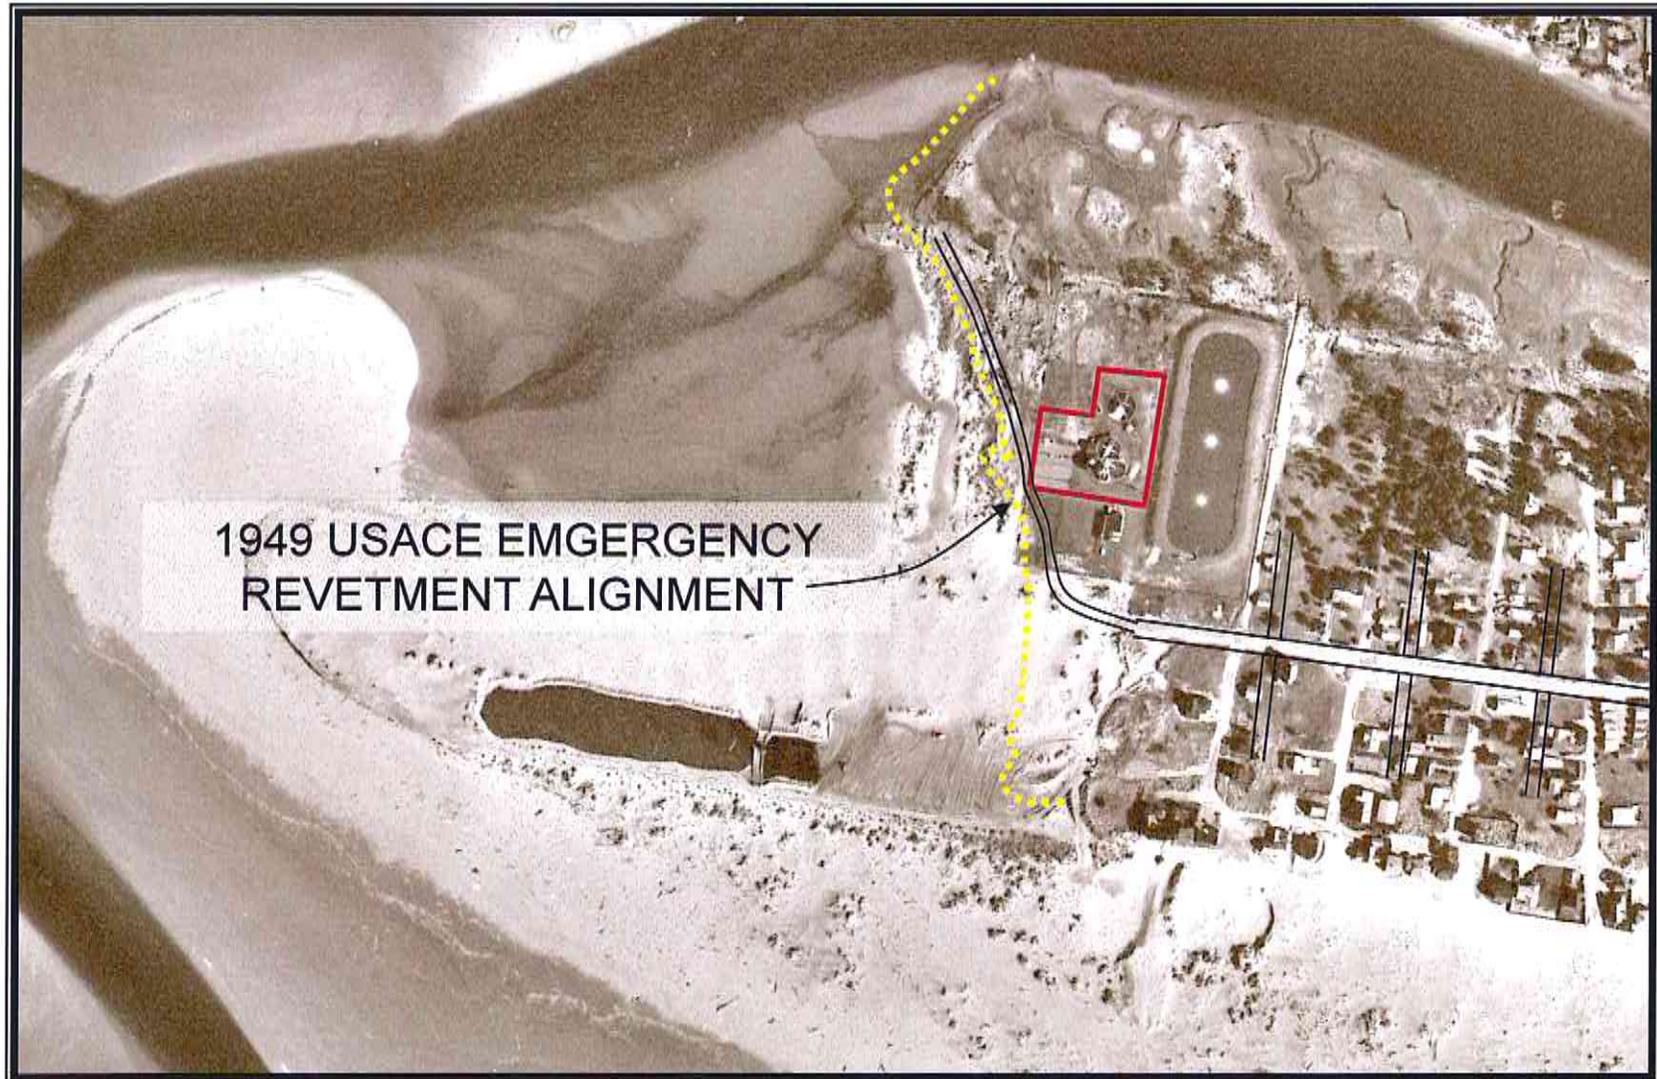
# 1978

Notice how the brush and vegetation are starting to take hold. The developer had been stopped on a shell fish bed violation and was ordered to cease and desist. He appealed the decision all the way to federal court where the justices ruled that states had the authority over their coast and waters. He did not have to remove any of the material he had placed, just let nature take its course.

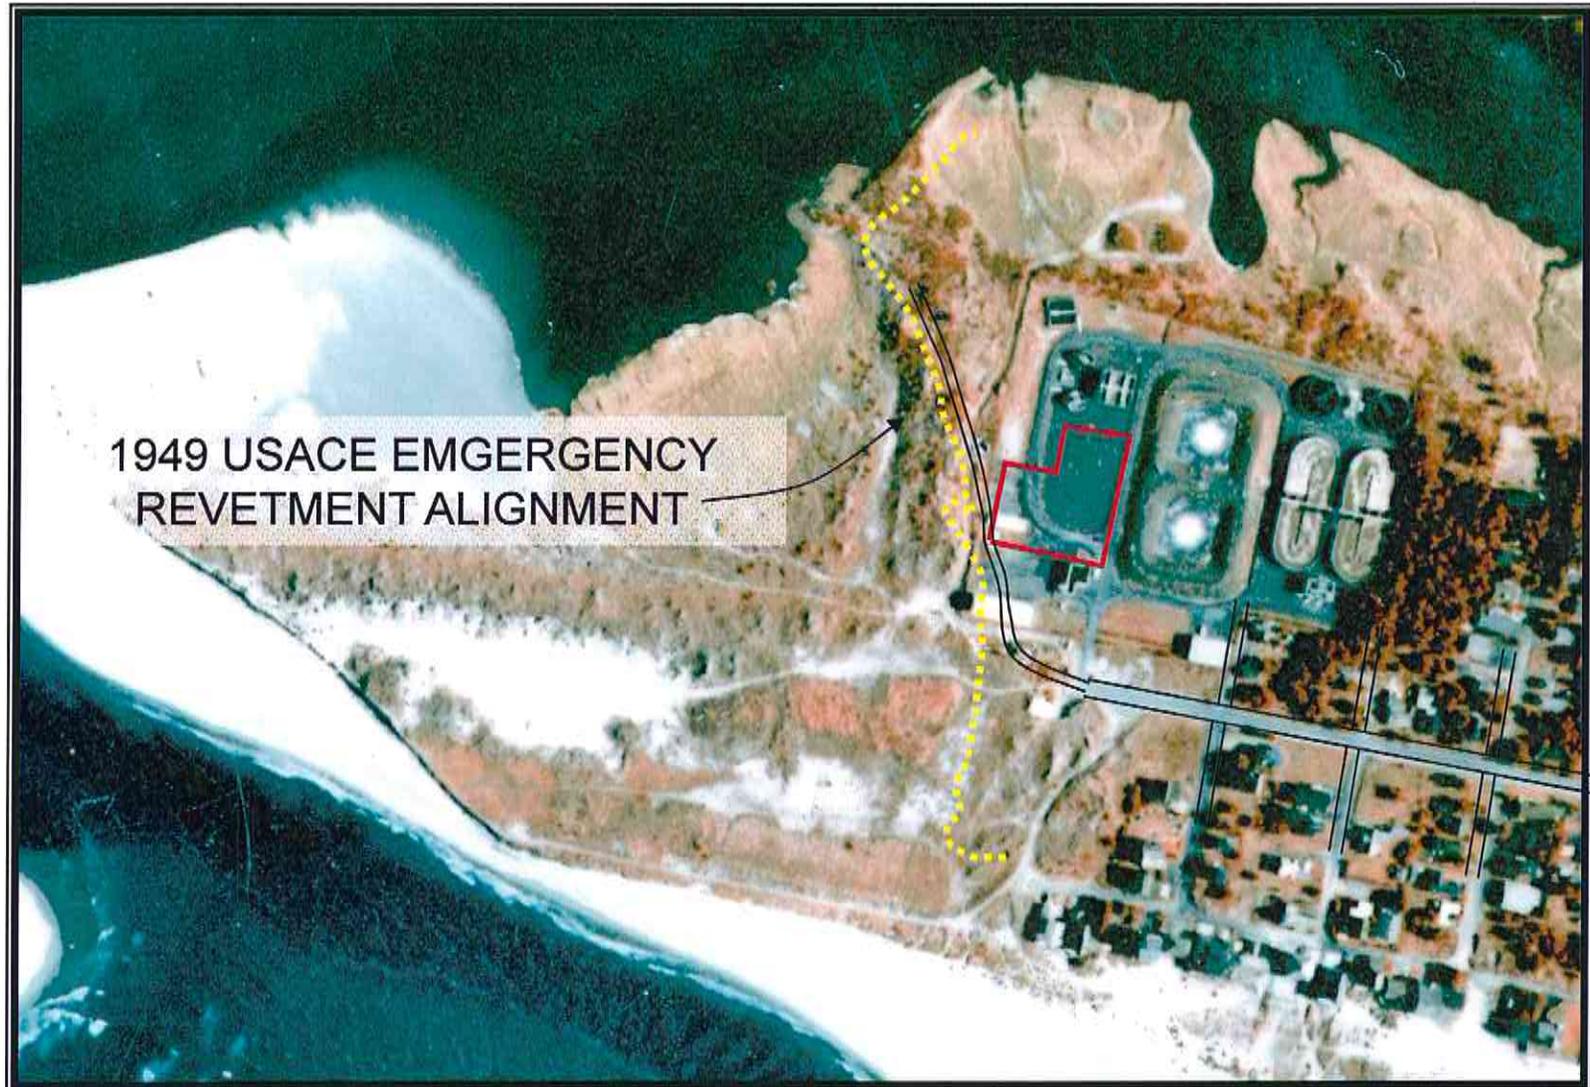
# 1989

Several note worthy items in this photo: The new sewer plant was opened in 1986 (the old is outlined in red). The mitigation area for Quatat Park, located east of the plant had been completed. Vegetation was well Established over most of the north spit. Notice how close in and heading south the river channel was.

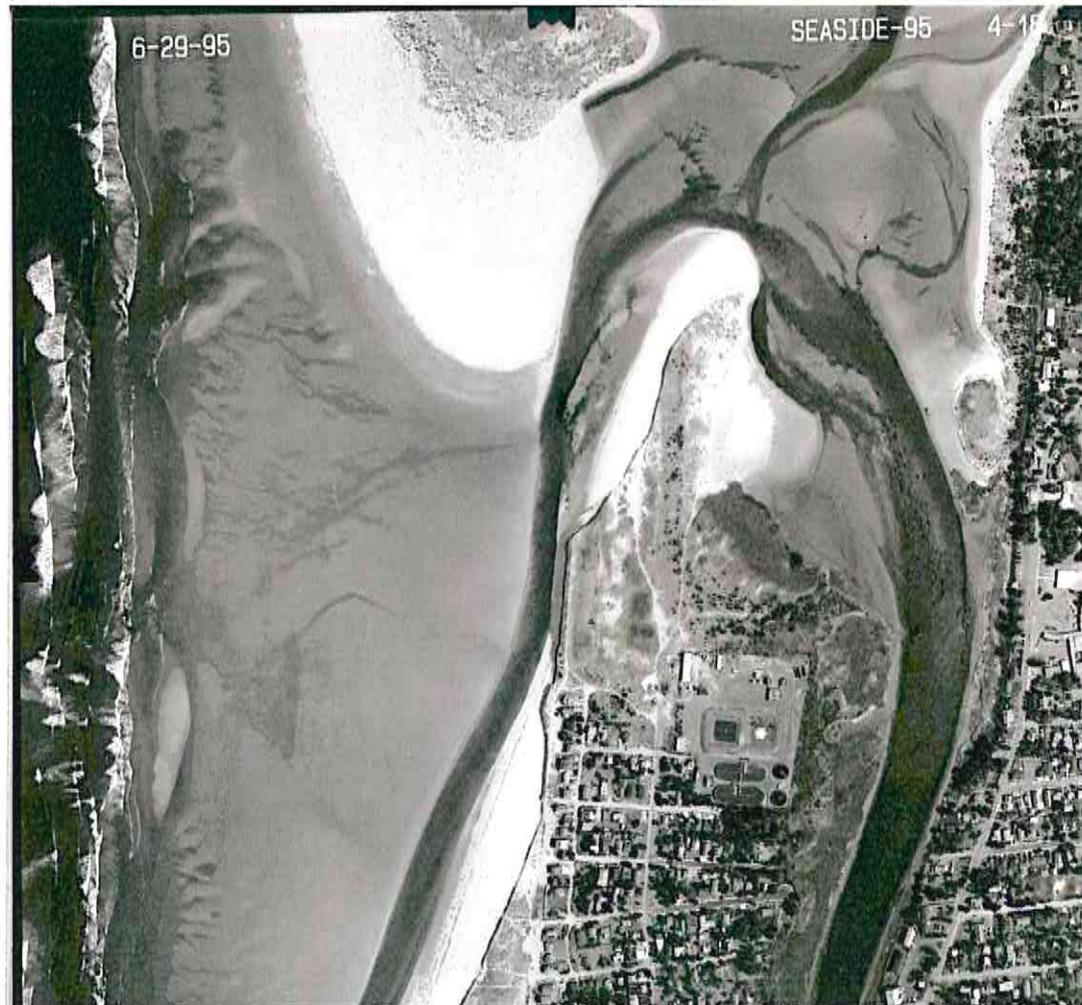
# 1995

The river mouth during this time was shown at low tide to be as far south as the Best Western between 4<sup>th</sup> and 5<sup>th</sup> Avenues.

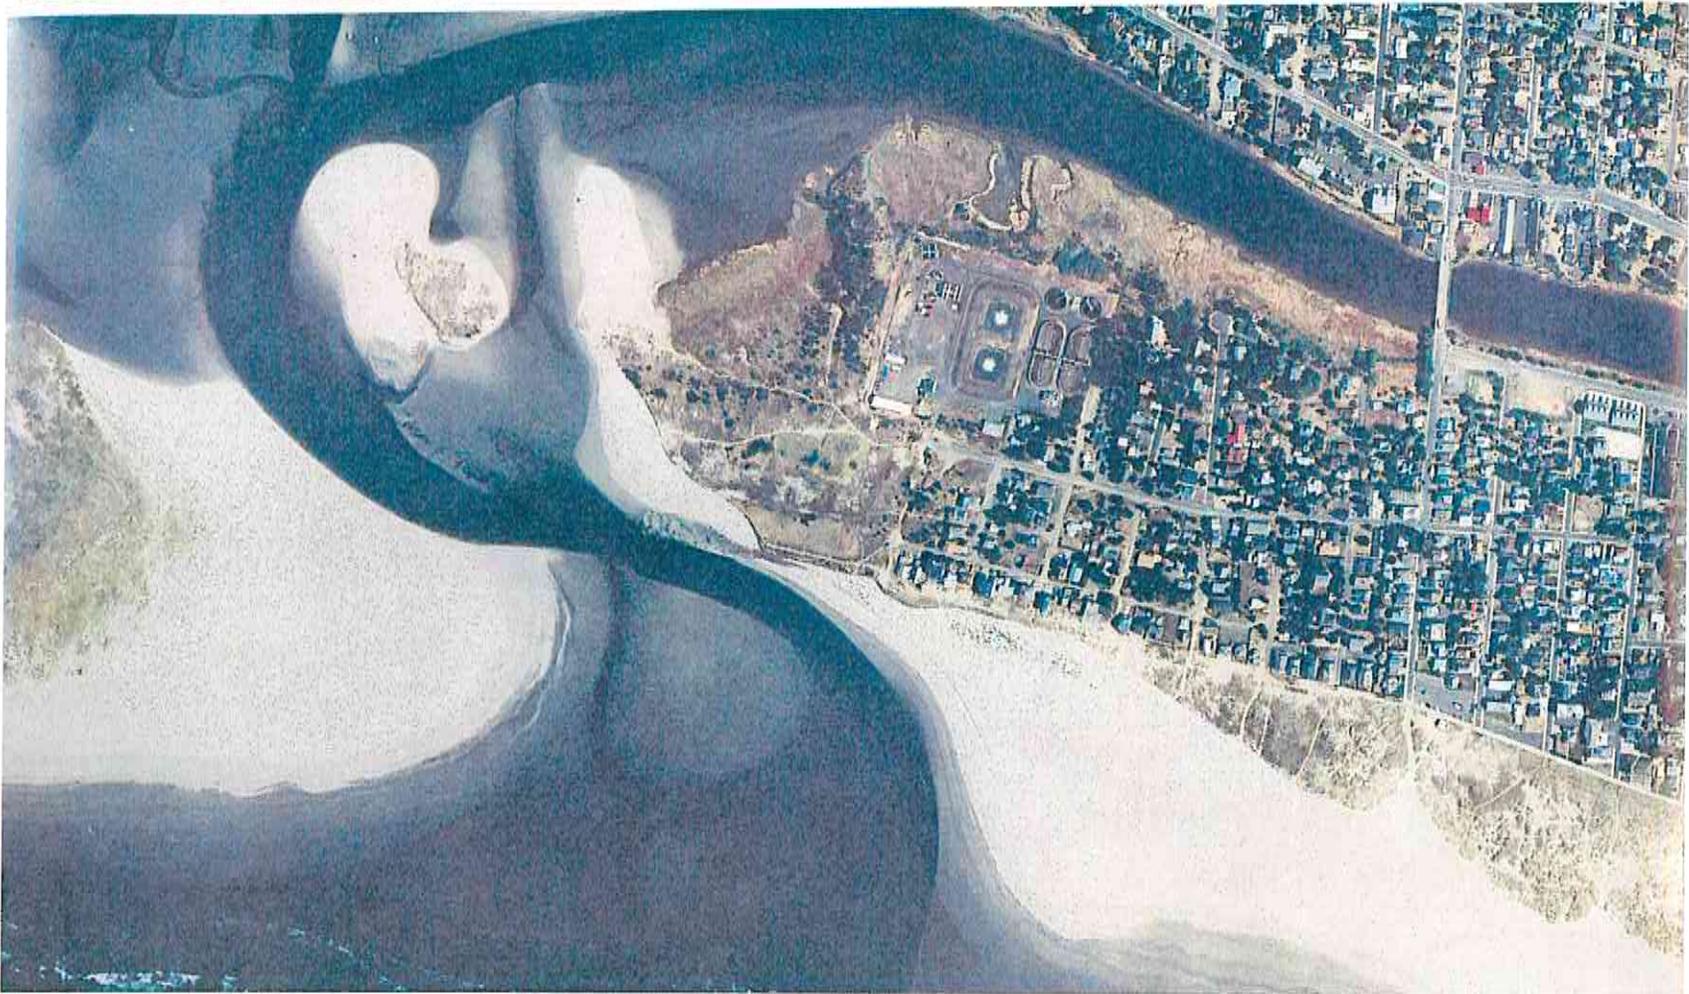
# 1998

After back to back years of 100 plus inches of rain, the decision to not allow housing on the north spit was proven to be a good one. The Necanicum began reclaiming its estuary. Notice the island that was created and the vegetation on it. You will see it many more times, but not like this.

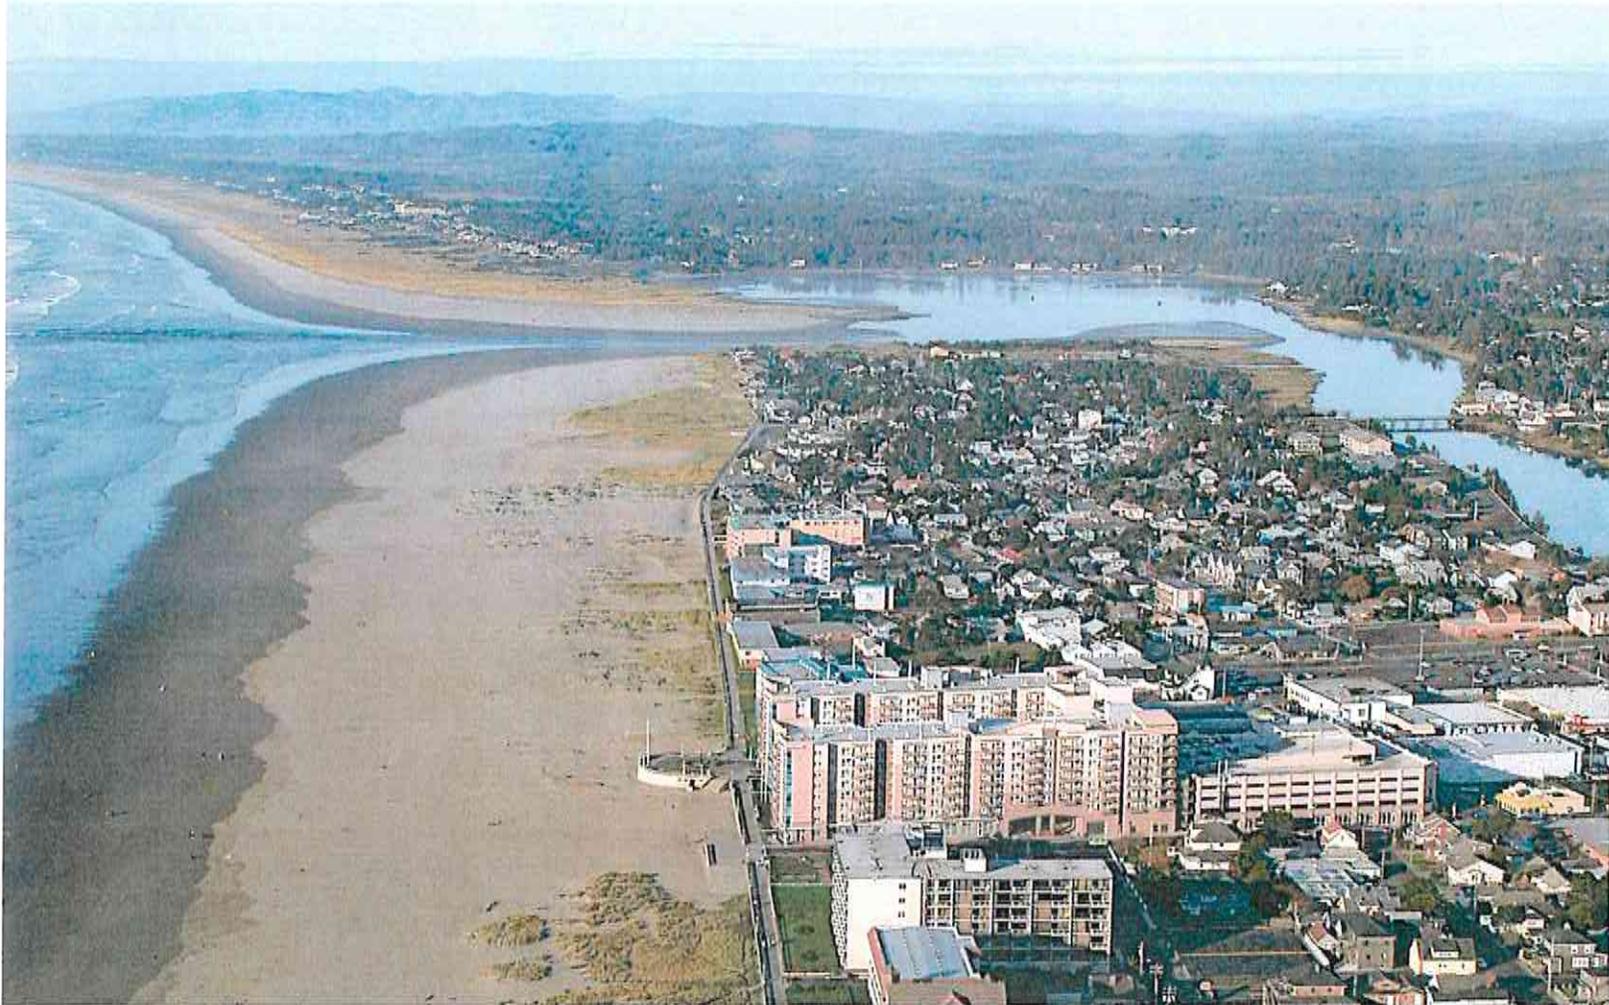
# 2002

Can you see in the distance the island from 1998? It is now attached to Gearhart.

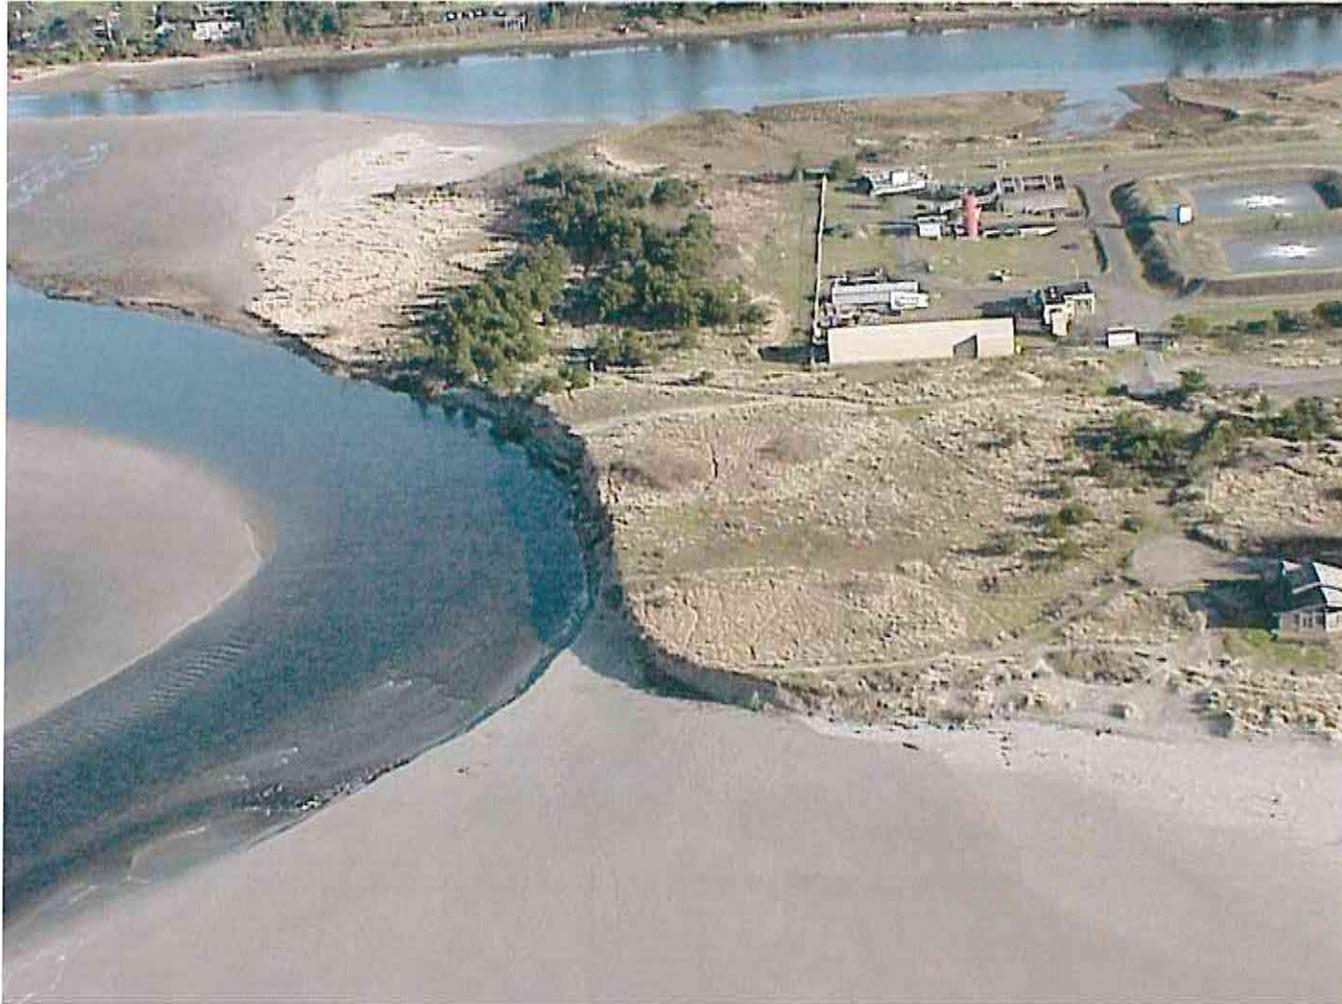
# January 2004

The river channel was making a real push to the south. If you look closely toward the Foreground in the channel you can see remnants of the rock used in 1967.

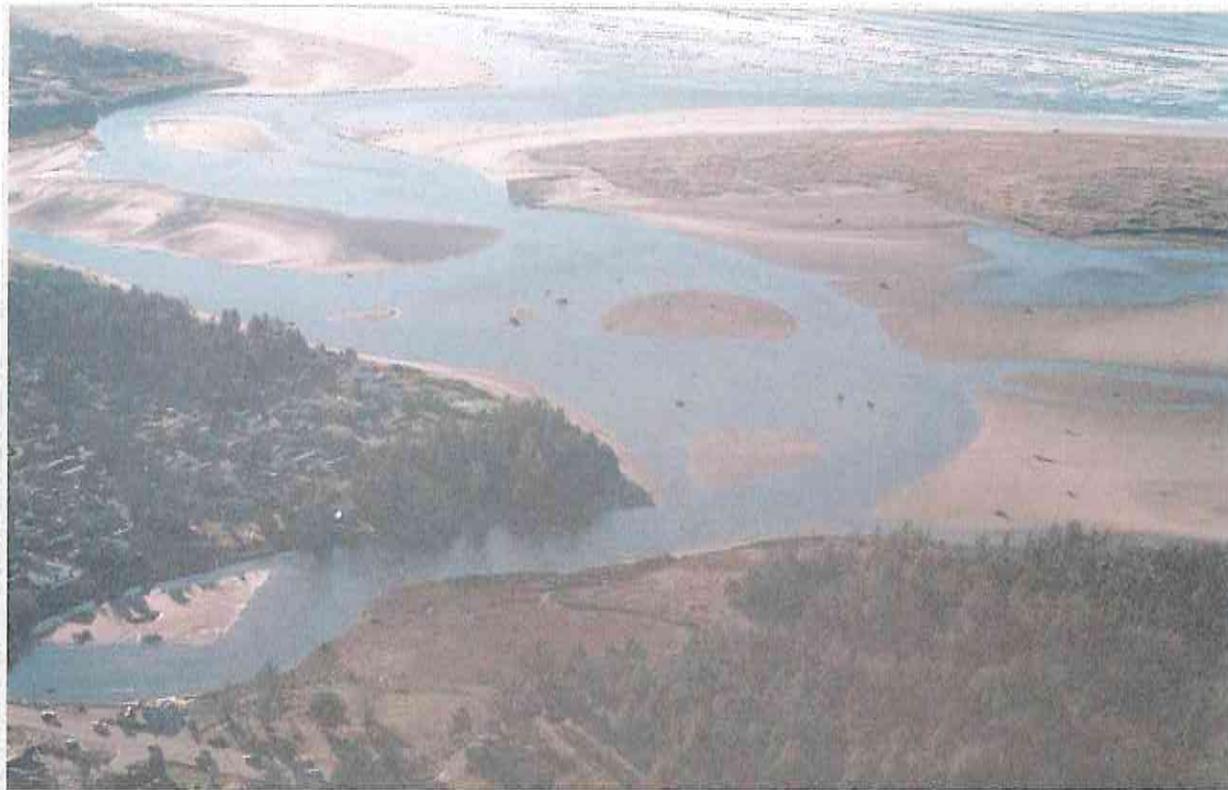
# January 2005

A very different angle with sewer plant in the extreme upper left hand corner. Can you still find The remains of the "island". It's in the upper center of the photo, now completely Incorporated into Gearhart. Notice how well the vegetation in Gearhart is established.

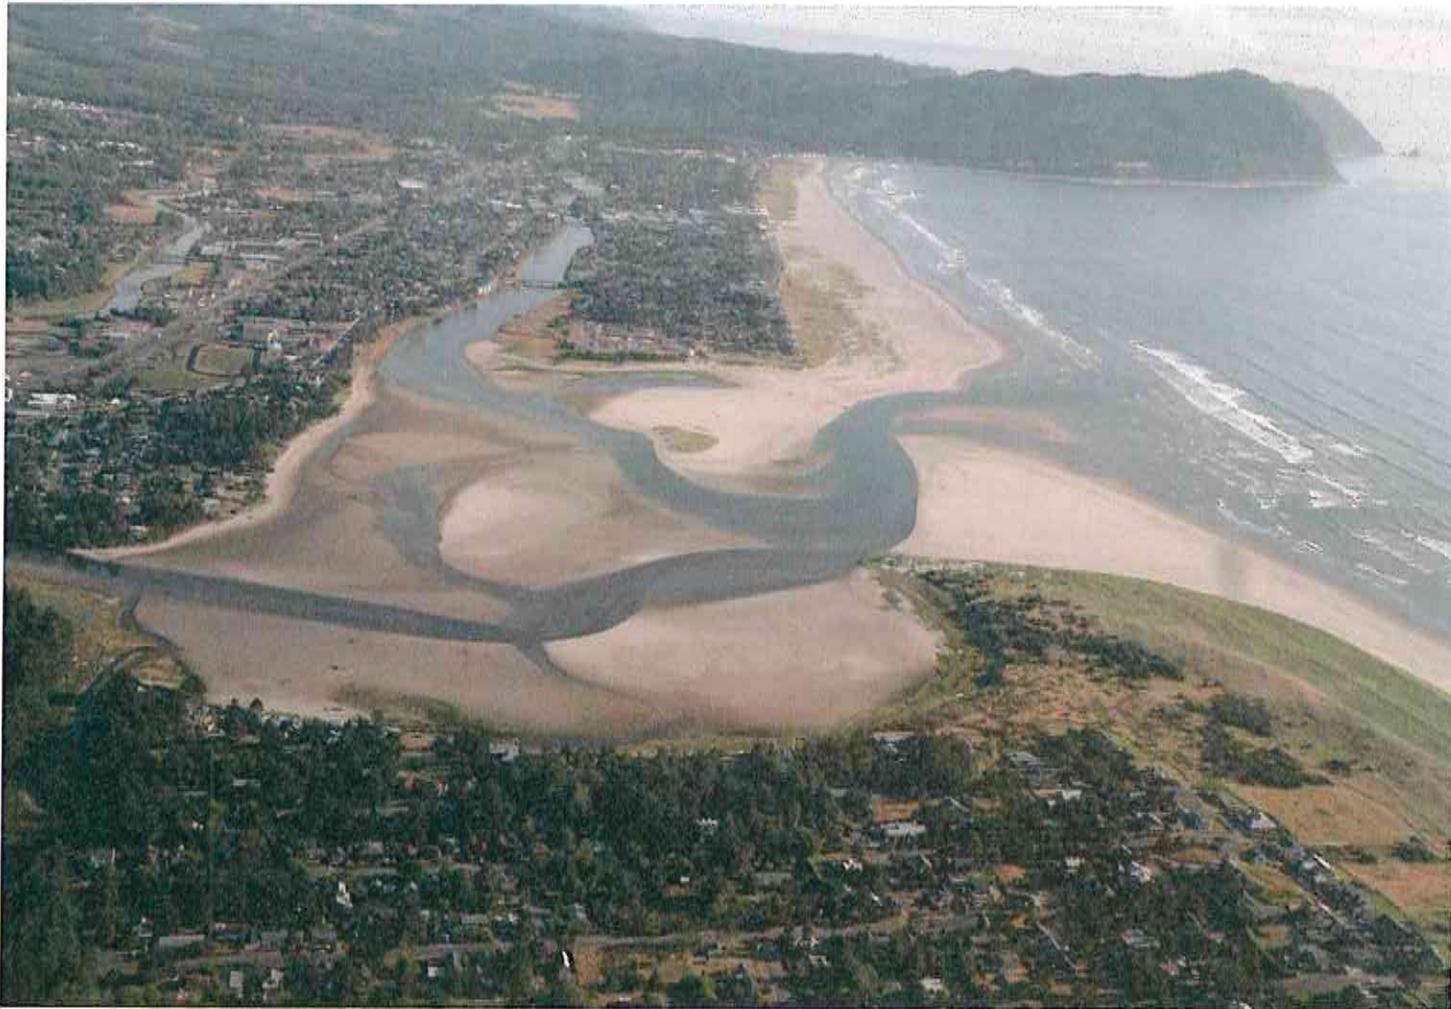
# August 2011

Notice that the channel is meandering around the bay but that the island is once again an island. You can clearly see the three drainages; Necanicum, Neawanna, and Neacoxie. During this time Gearhart residents were concerned with erosion and it got worse on the north for the next months.

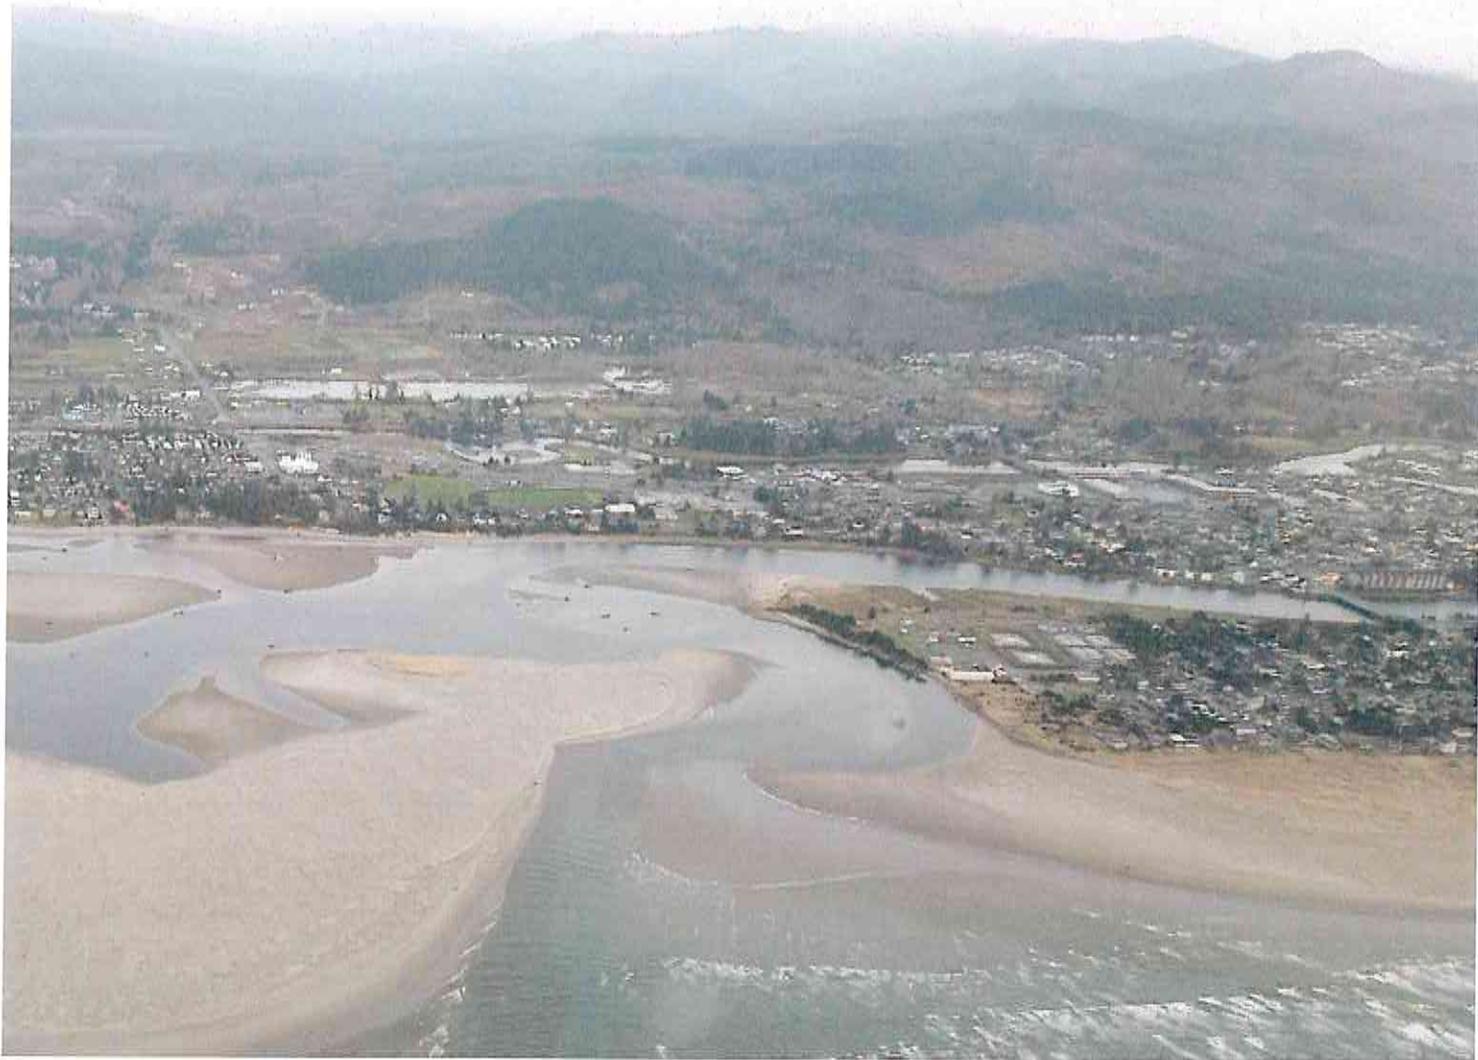
# March 2013

The bank is only 30 feet from the northwest corner of the plant. You can see the "island at the tip of the whale's tale, now attached to Gearhart in a different way.

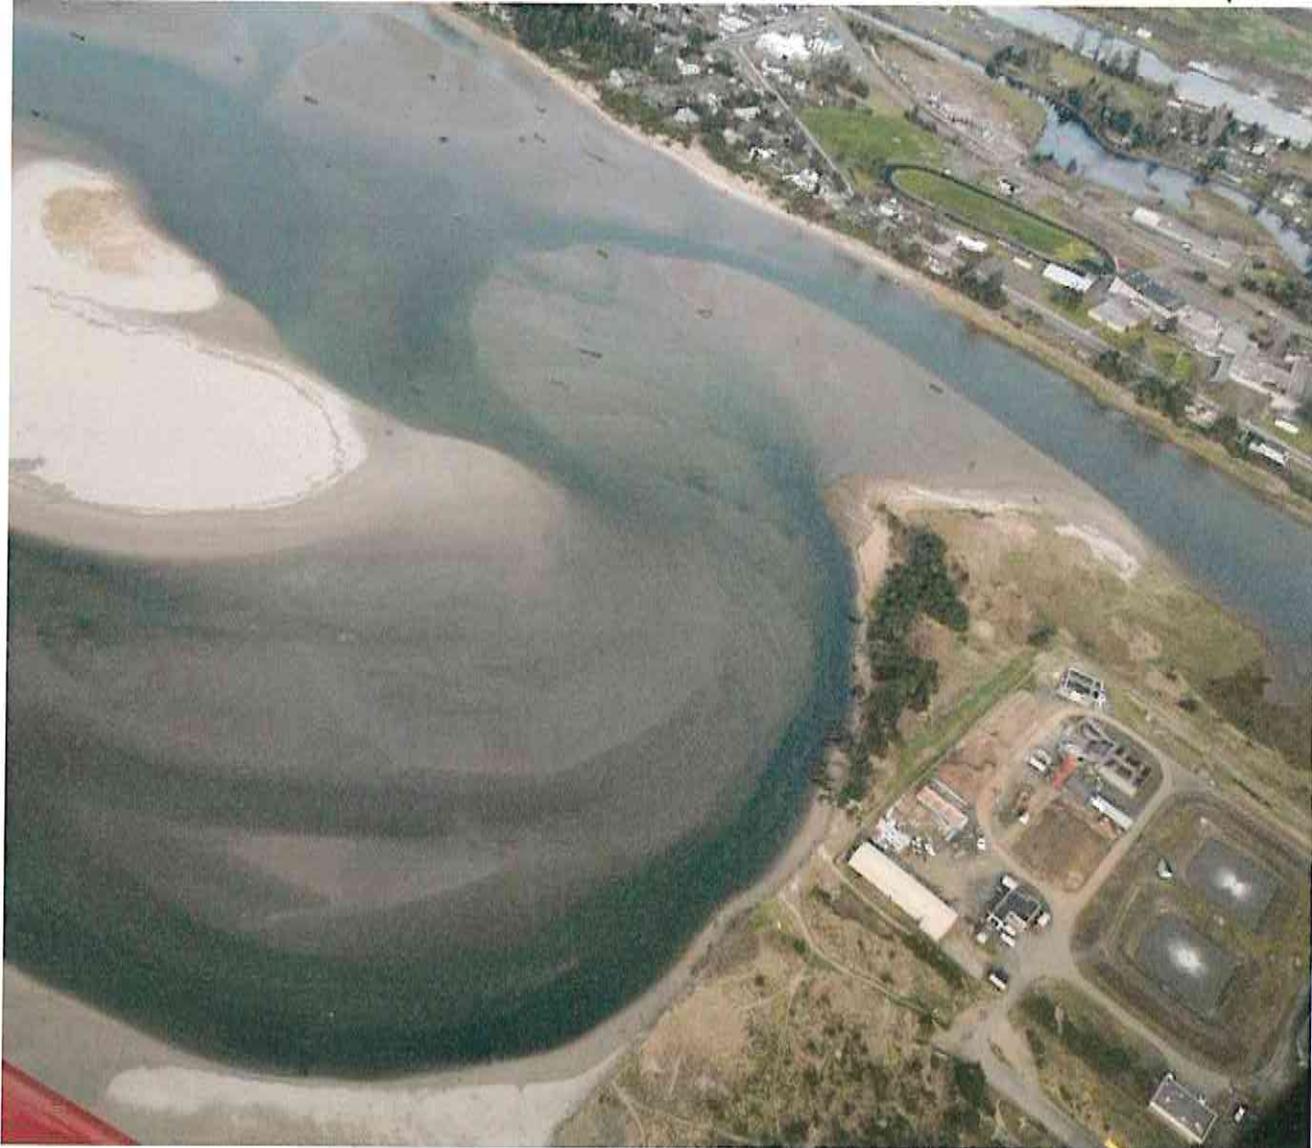
# April 2013

Now it is 25 feet from the corner and we are losing more pine trees every day. As alarming as this appears, it has still not come in contact with the revetment the Corps of Engineers placed Back in the 40's. As we come into summer and the prevailing winds come out of the northwest, We often see sand start to build back in and the channel start to normalize. Let's hope.
